TANK 4 AND LEACHATE TRANSMISSION SYSTEM REPORT

CONSTRUCTION QUALITY ASSURANCE (CQA)

ERDF CONSTRUCTION CELLS 9-10

## CQA PHOTOGRAPH LOG WEEK 35 (10/4/10 TO 10/9/10)

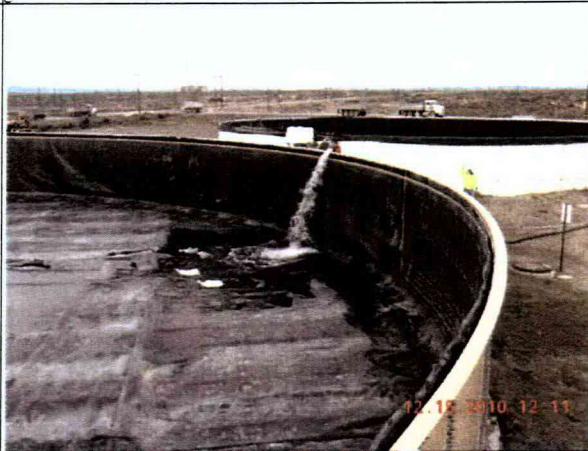
Facing SW - TWS filling Tank 4 with water for the electronic leak detection survey.

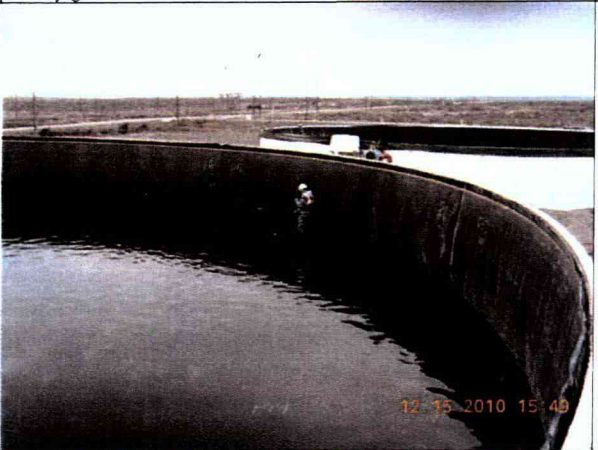
Facing NE - LLS performing the leak detection survey on the primary geomembrane in Tank 4.

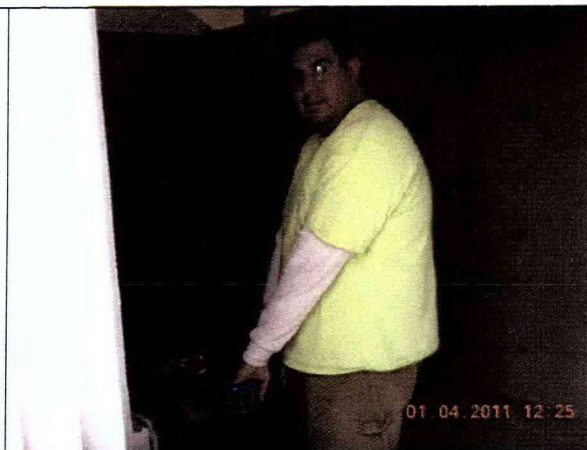
Facing SW – Purcell sanding the floor of Crest Pad 10.

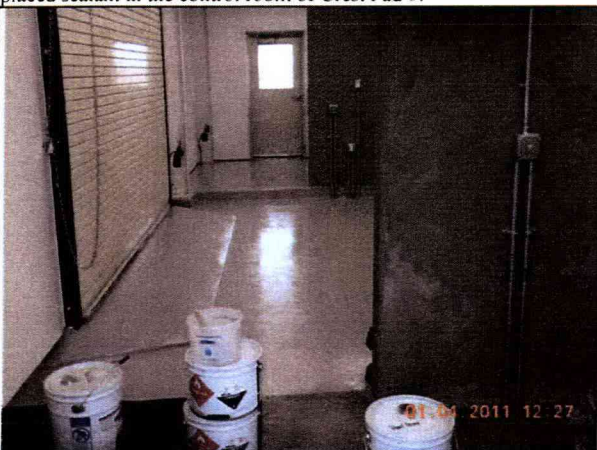
Facing E – Purcell completed coating the floor of Crest Pad 9 with Amerlock 400.

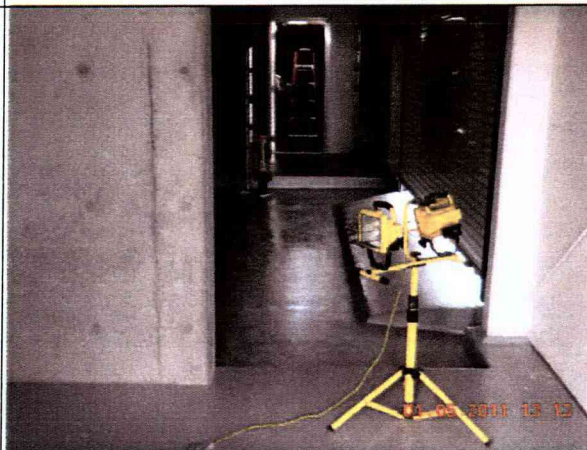
Facing W – Purcell completed coating the floor of Crest Pad 10 with Amerlock 400 and placing sealant on the floor of the control room.

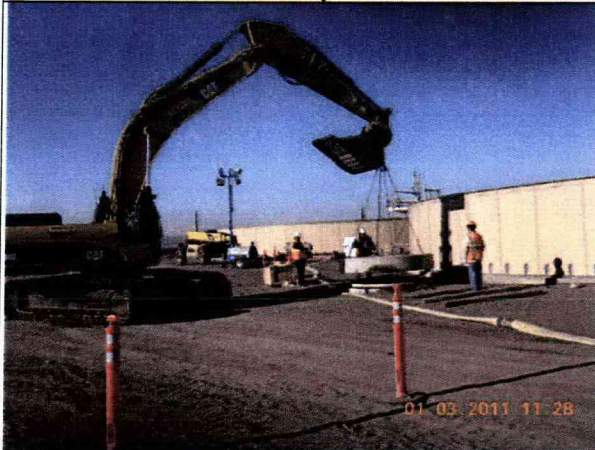
Facing NW – TWS lifting the top section off of MH-39.

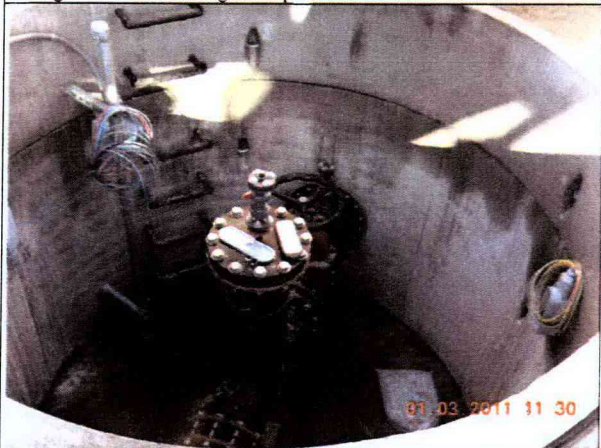
Facing NE – The existing piping and valve in MH-39

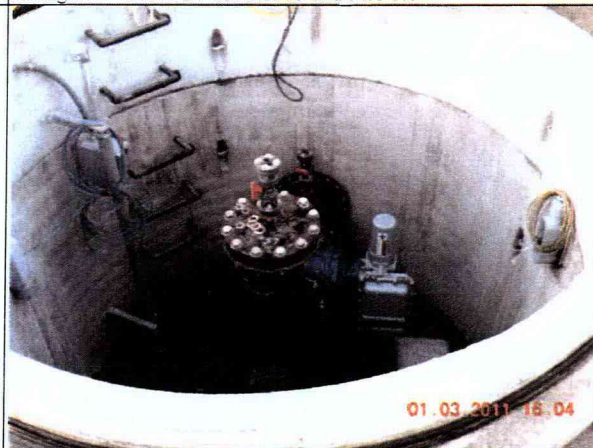
Facing NE – The existing piping and new MOV valve installed in MH-39.

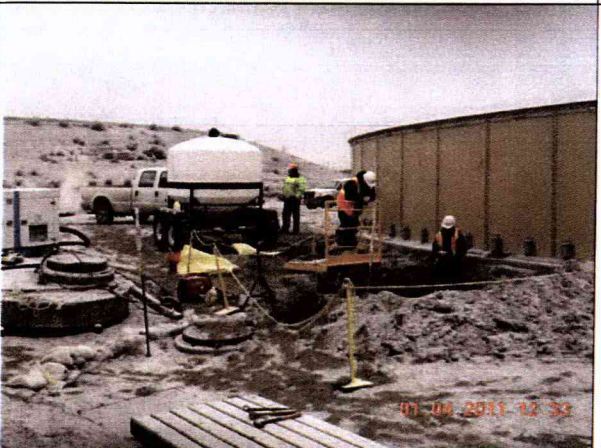
Facing S – Stoller removing the leachate from the pipe upstream of MH-17.

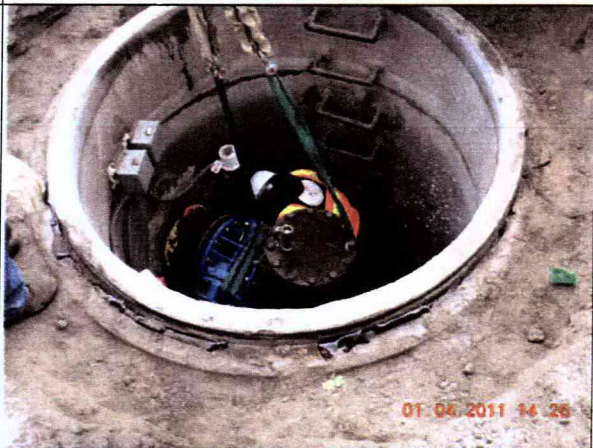
Facing down – BMWC removing the existing MOV and piping from MH-17

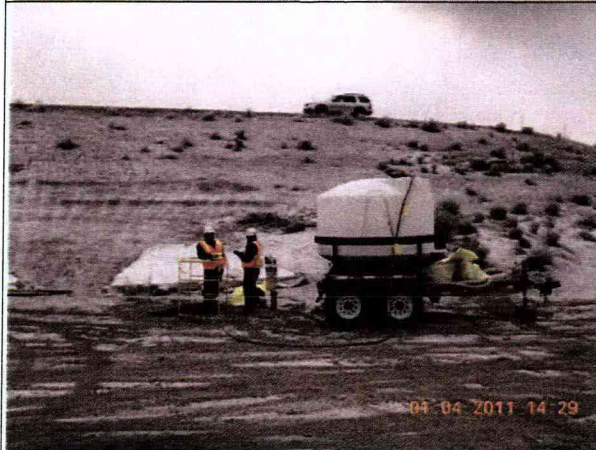
Facing S – Stoller removing the leachate from the piping upstream of MH-9.

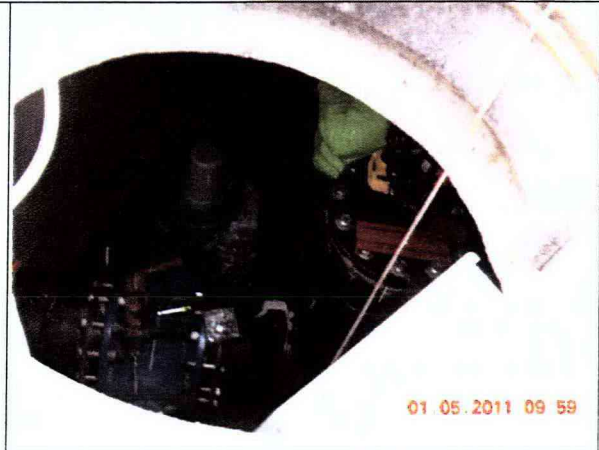
Facing down – American electric installing the electrical components of the MOV in MH-39.

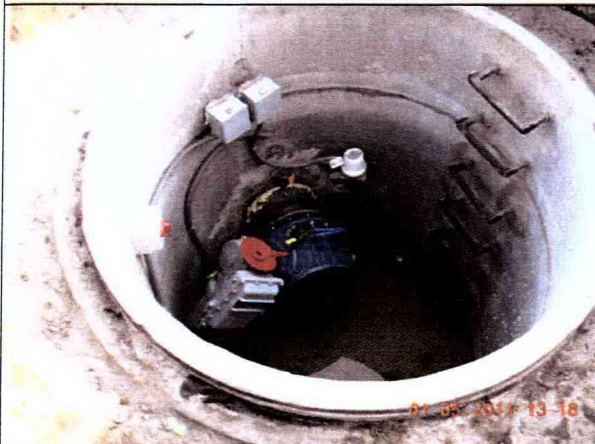
Facing SE – BMWS installed the new MOV in MH-17. The MOV had to be tilted sideways to fit in the manhole.

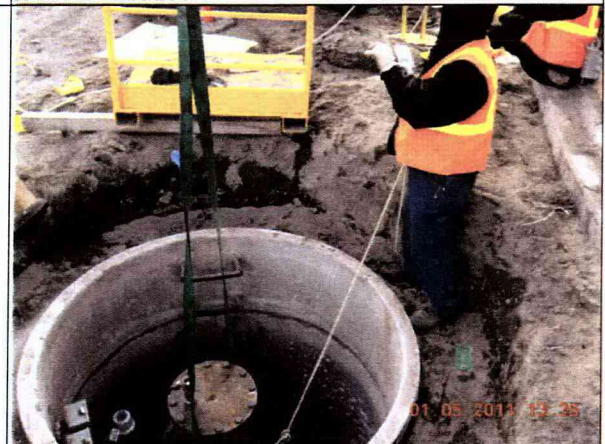
Facing SE – BMWC replacing the existing piping in MH-17.

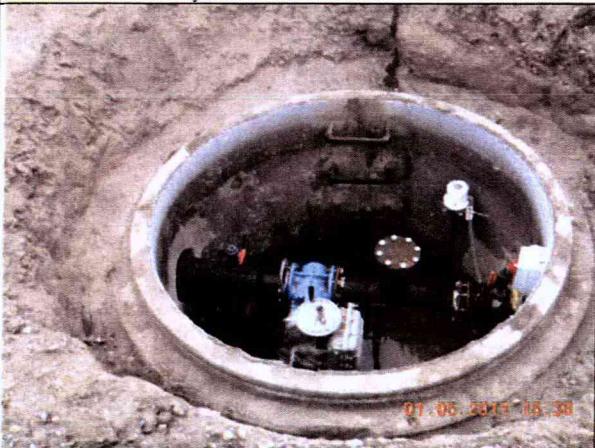
Facing NW – The existing piping in MH-18.

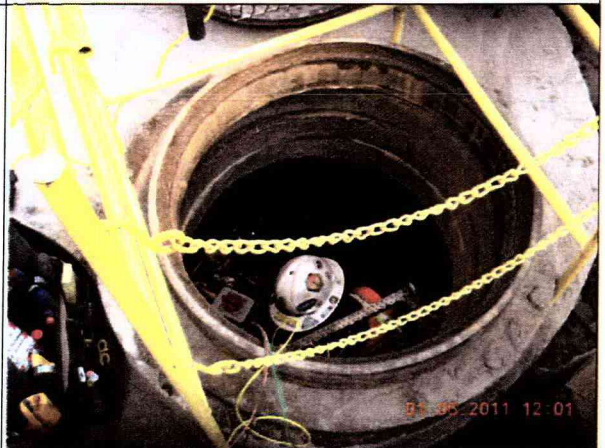
Facing down – American electric installing the electrical components of the MOV in MH-18.

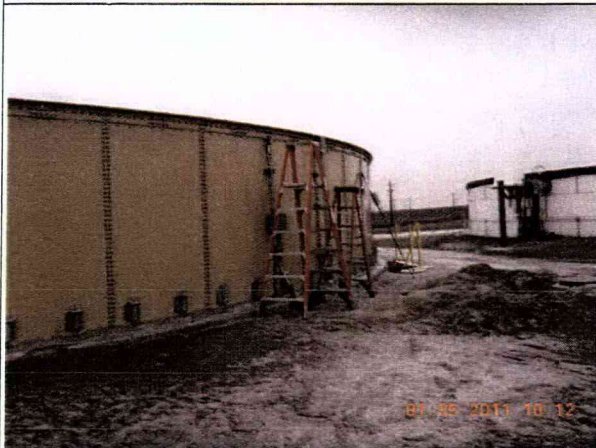
Facing NW – BMWC installed the transducer pipe inside of Tank 4 and the transducer calibration pipe on the outside of Tank 4.

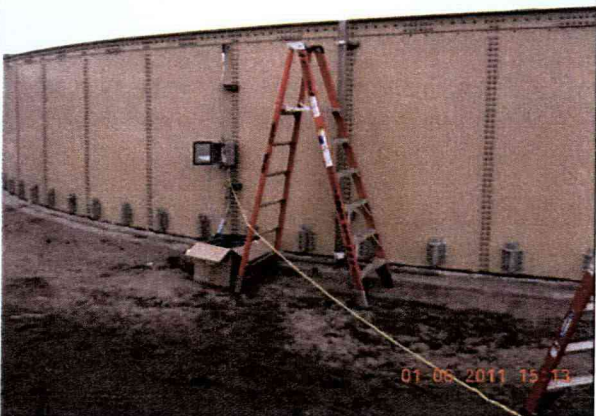
Facing SW – The transducer calibration pipe was installed on the outside of Tank 4.
